Steering System Analysis and Modification of 8x8 Scaled Electric Combat Vehicle (SECV)

Aliyah Jimoh, Macrina Moye, Naeem Ullah, Risto Tasev, Rusham Ahmad

Supervising Professor: Dr. Moustafa El-Gindy

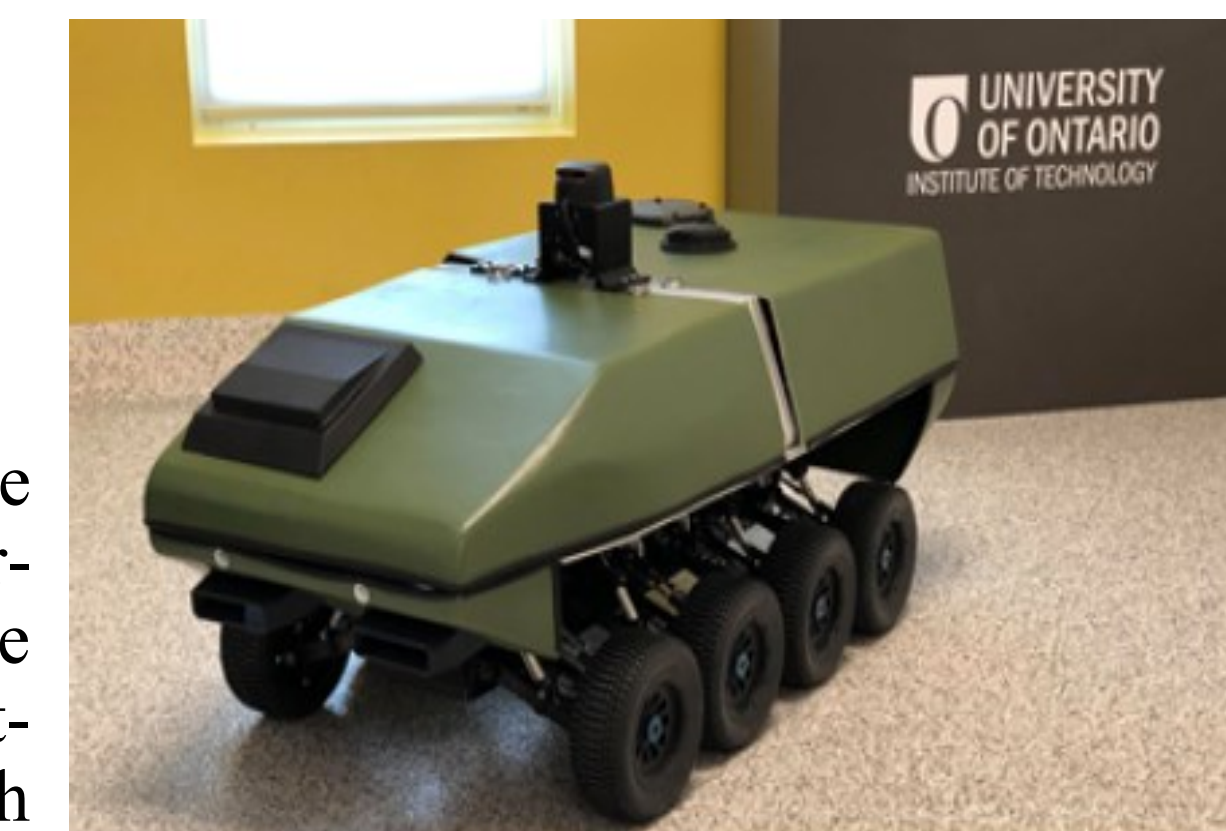
Future Development

- Use a protractor table setup with a laser connected to a tire to gather data which can be analyzed to determine level of misalignment in wheels.
- Change materials of parts on the vehicle to increase durability, i.e. stainless steel, aluminum.
